L:\Projects\041560\1973\Reports\252\CA 04 1973 002_Caulking Remediation.dwg, Aug 16, 2016 10:09am, lusted

GYM BUILDING
NOT TO SCALE

POD / LIBRARY BUILDING
NOT TO SCALE

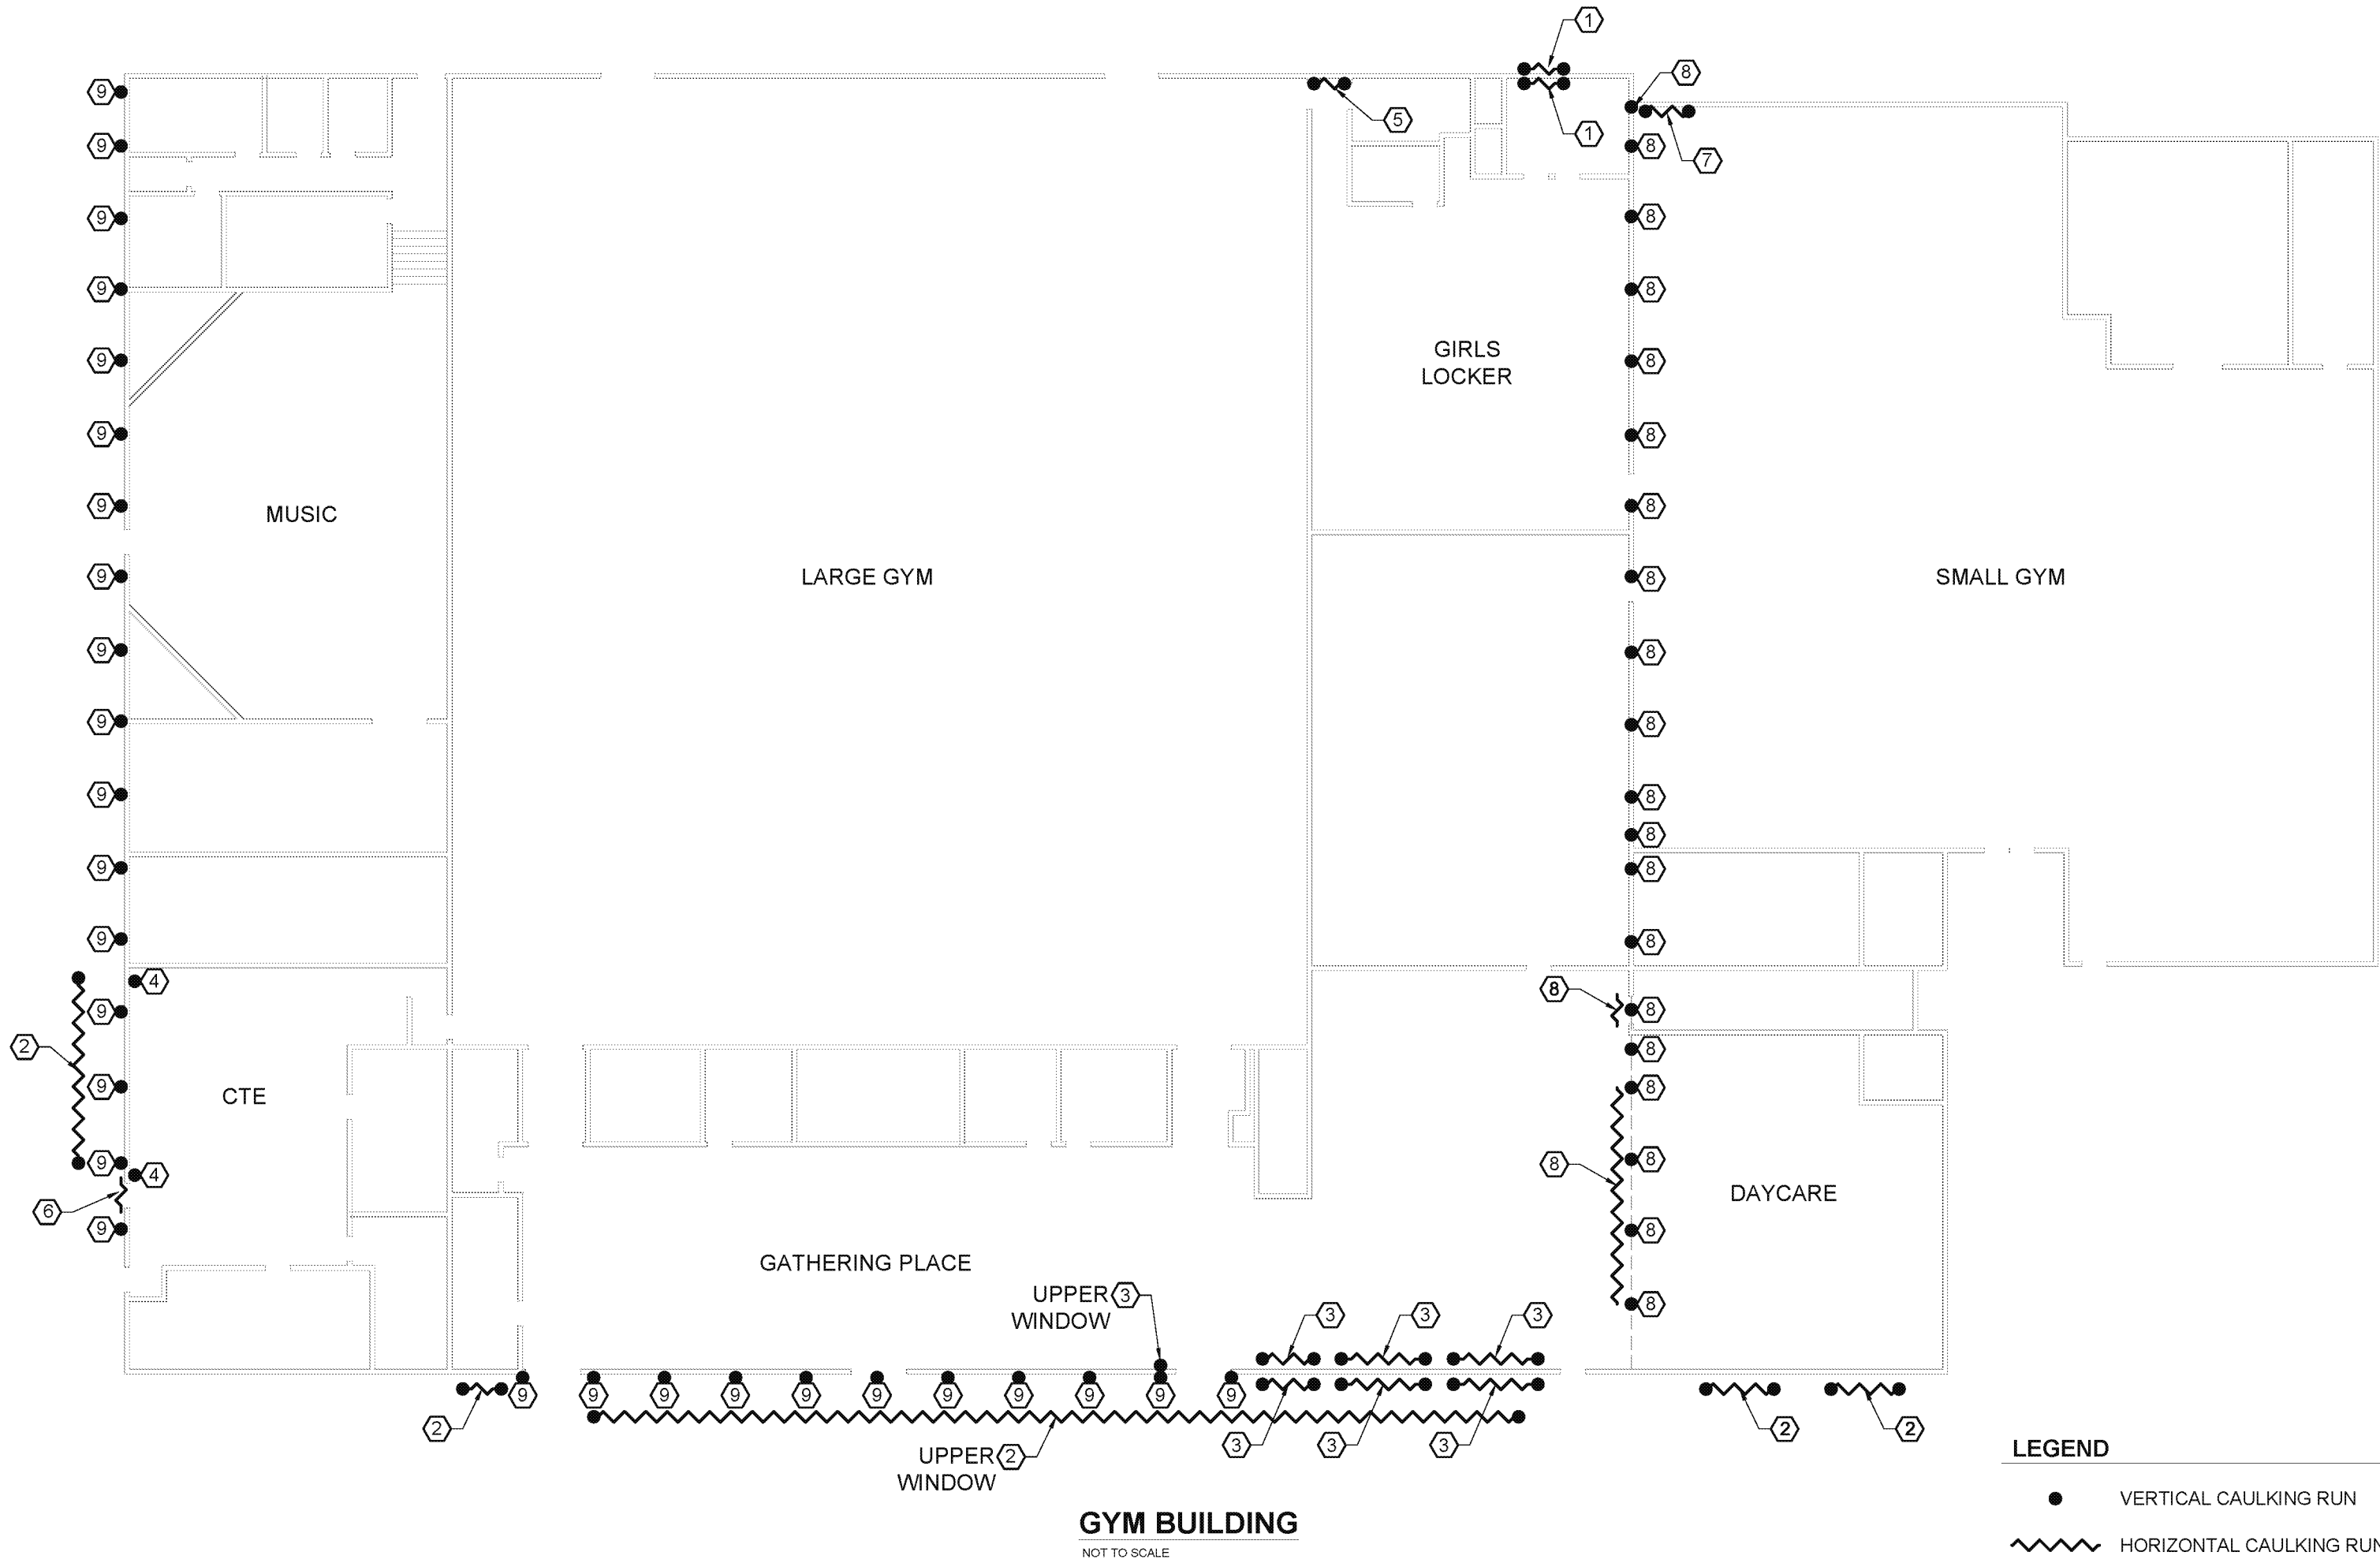
- ① REMOVE APPROX. 20 LF OF PCB-CONTAINING CAULKING LOCATED ON THE EXTERIOR AND INTERIOR METAL WINDOW FRAME ON THE GIRLS LOCKER ROOM NORTH PERIMETER WINDOW AS SHOWN.

- ② REMOVE APPROX. 300 LF OF PCB-CONTAINING CAULKING ON THE EXTERIOR METAL WINDOW FRAMES ON ALL WINDOWS AT THE SOUTH AND WEST ELEVATIONS OF THE LARGE GYM BUILDING AS SHOWN. THIS INCLUDES CAULKING THAT EXISTS AROUND EACH WINDOW INFILL PANEL METAL FRAME TRANSITION ON THE WEST ELEVATION. THESE INFILL PANELS ARE CEMENT ASBESTOS BOARD.

- ③ REMOVE APPROX. 40 LF OF PCB-CONTAINING CAULKING LOCATED ON INTERIOR SIDE OF THE THREE LOWER WINDOWS AND THE UPPER WINDOW BANK EAST VERTICAL IN THE GATHERING PLACE AS SHOWN.

- ④ REMOVE APPROX. 10 LF OF PCB-CONTAINING OF CAULK ON INTERIOR WINDOW FRAME VERTICALS IN THE CTE ROOM AS SHOWN.
- ⑤ REMOVE APPROX. 18 LF OF PCB-CONTAINING OF CAULK ON INTERIOR SIDE OF NORTH EXTERIOR GIRLS LOCKER ENTRY DOOR AS SHOWN.

- ⑥ REMOVE APPROX. 18 LF OF PCB-CONTAINING OF CAULK ON EXTERIOR SIDE OF NORTH CTE ENTRY DOOR AS SHOWN.
- ⑦ REMOVE APPROX. 18 LF OF PCB-CONTAINING OF CAULK ON THE INTERIOR SIDE OF THE NORTHWEST PERIMETER ENTRY DOOR FRAME OF THE SMALL GYM AS SHOWN.

- ⑧ REMOVE APPROX. 500 LF OF PCB-CONTAINING CAULKING LOCATED ON ALL VERTICAL STRUCTURAL METAL COLUMN TRANSITIONS THROUGHOUT THE EAST ELEVATION OF THE LARGE GYM AS SHOWN. THIS INCLUDES THE REMOVAL OF ALL CAULKING ON THE INTERIOR DEMISING WALL METAL BEAMS (VERTICAL AND HORIZONTAL) BETWEEN THE DAYCARE AND THE GATHERING PLACE/CAFETERIA AS SHOWN. THE CAULKING IS HEAVILY PAINTED THROUGHOUT THE WORK SCOPE AREA.

- ⑨ REMOVE APPROX. 780 LF OF PCB-CONTAINING CAULKING LOCATED ON ALL EXTERIOR VERTICAL STRUCTURAL METAL COLUMN TRANSITIONS THROUGHOUT THE LOWER WEST AND SOUTH ELEVATIONS OF THE LARGE GYM BUILDING AS SHOWN.

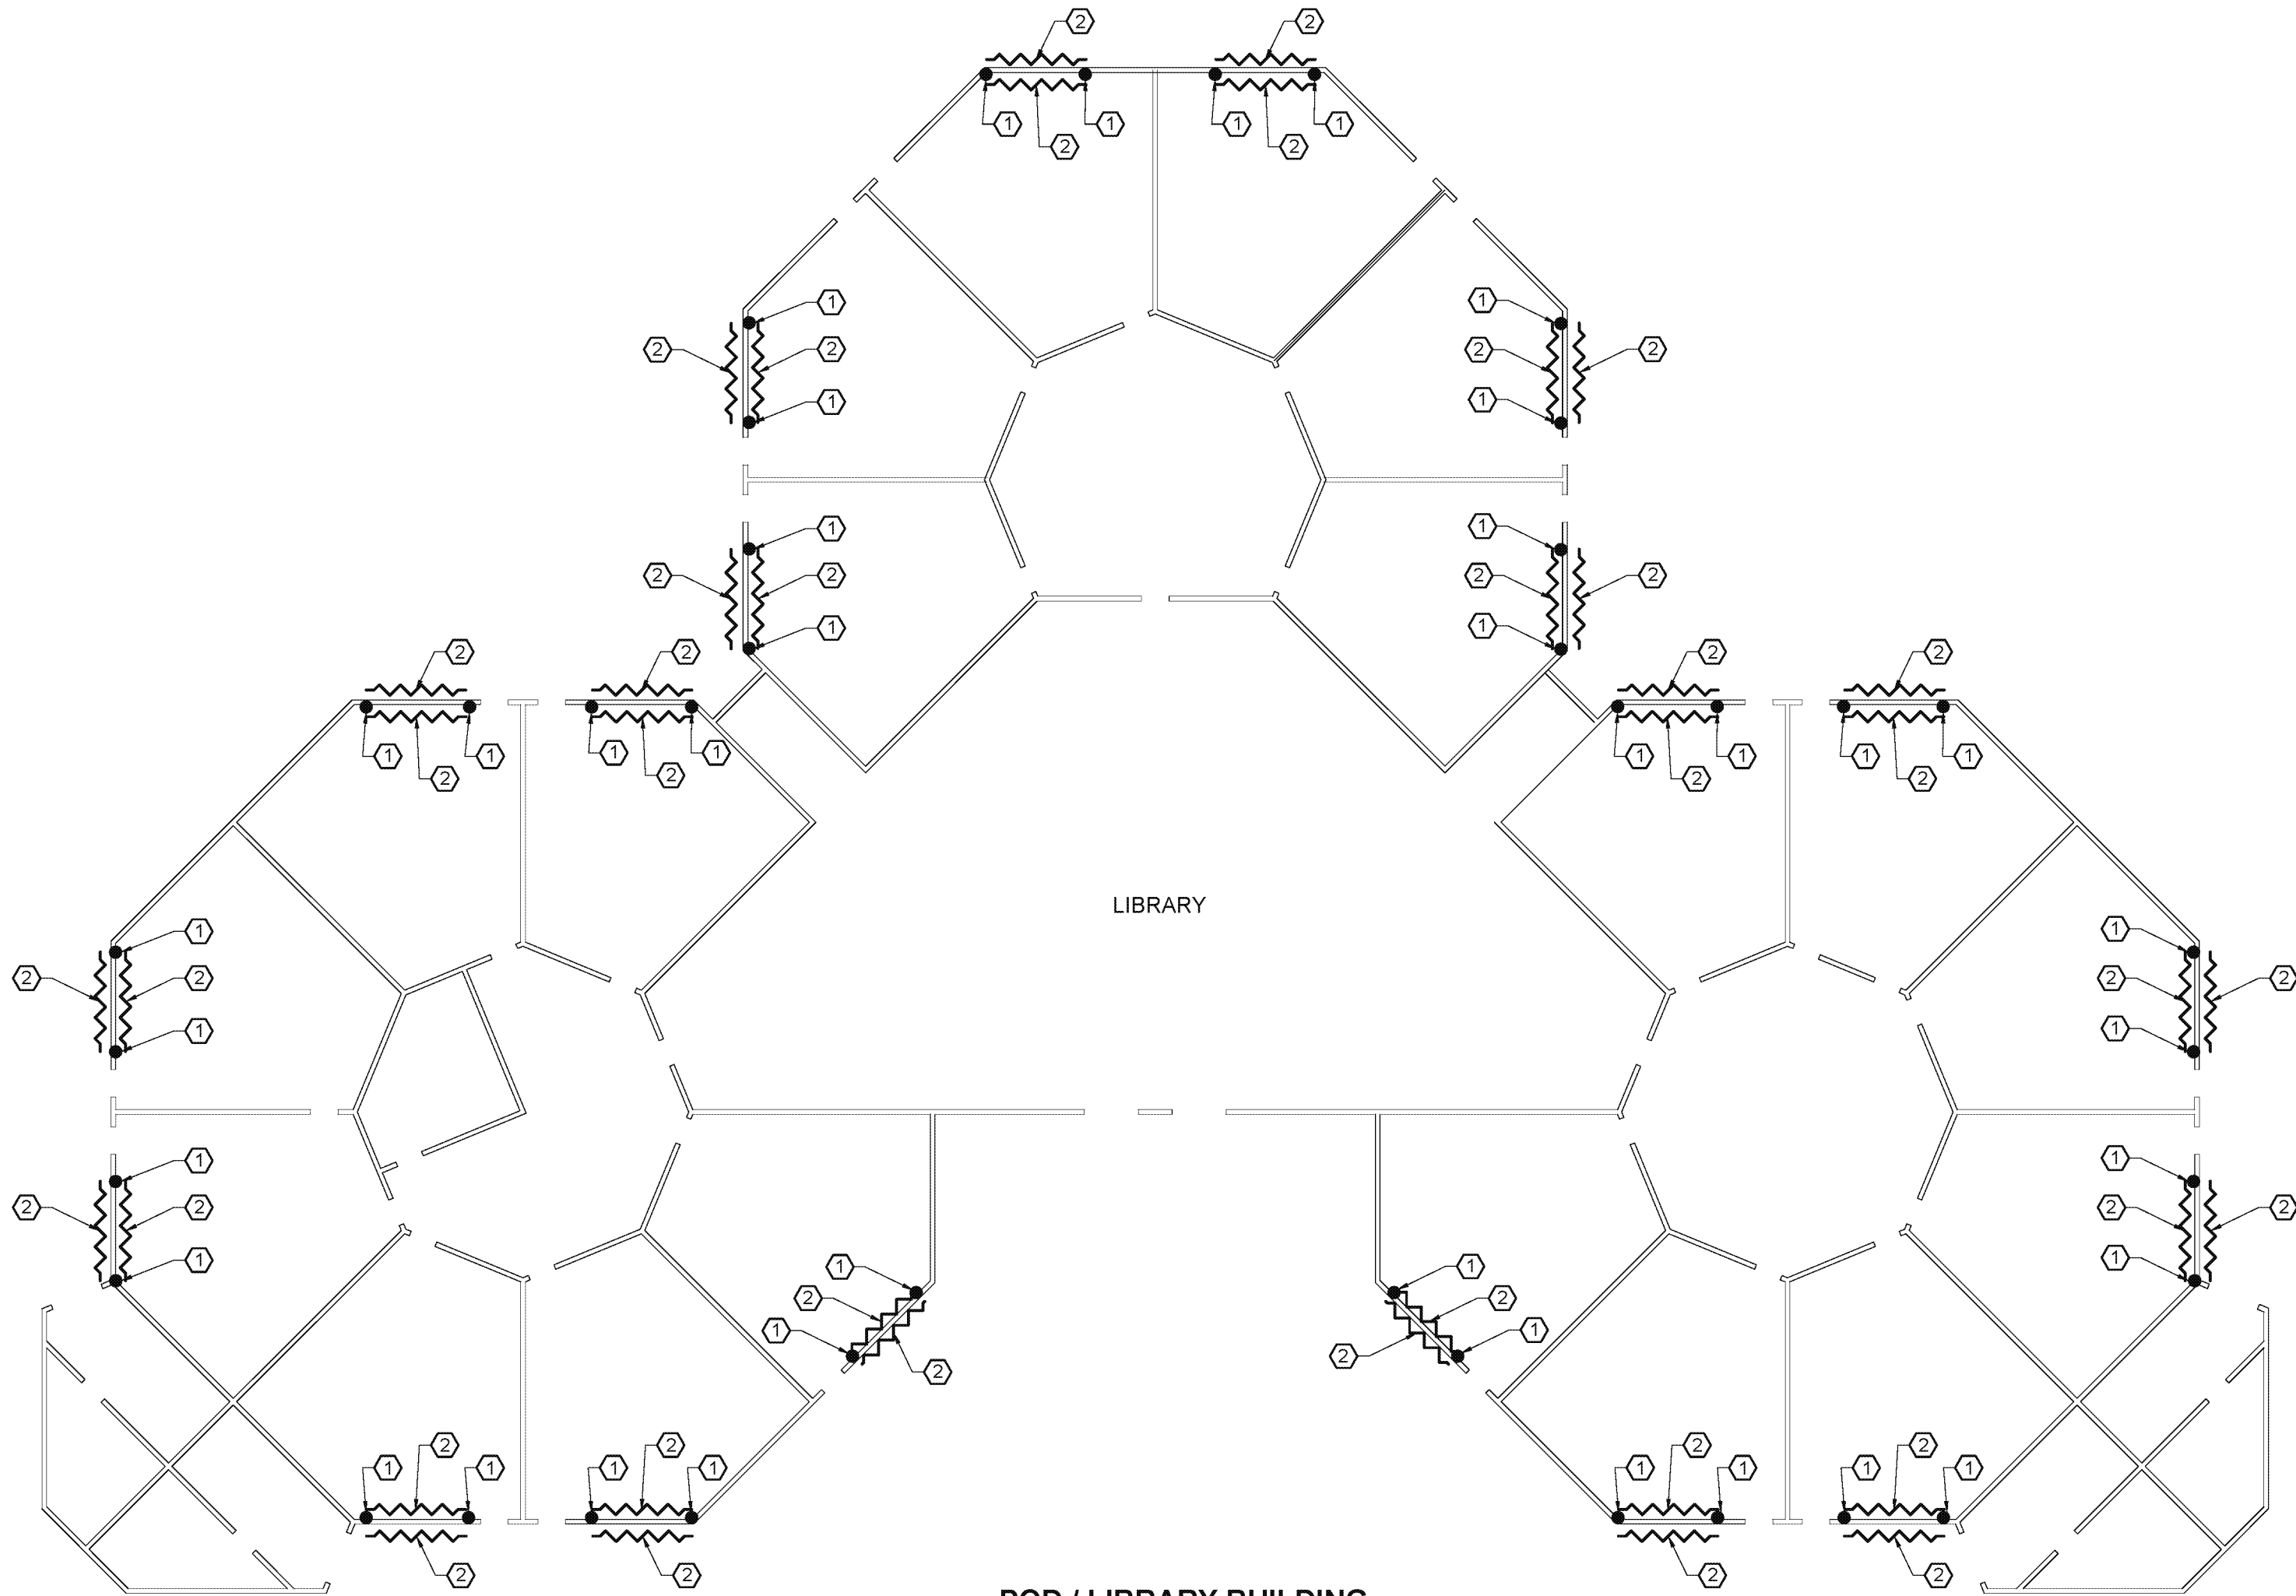
- ① REMOVE APPROX. 500 LF OF PCB-CONTAINING CAULKING LOCATED ON INTERIOR PERIMETER METAL WINDOW FRAME TO BRICK TRANSITION VERTICALS IN EACH OF CLASSROOMS 1-20 AS SHOWN.
- ② REMOVE APPROX. 1,400 LF OF PCB-CONTAINING CAULKING ON THE INTERIOR AND EXTERIOR SIDES OF THE CEMENT ASBESTOS BOARD (CAB) WINDOW INFILL PANELS. THE CAULKING FILLS THE GAP BETWEEN THE METAL WINDOW FRAME AND CAB TRANSITION IN EACH OF CLASSROOMS 1-20 AS SHOWN.

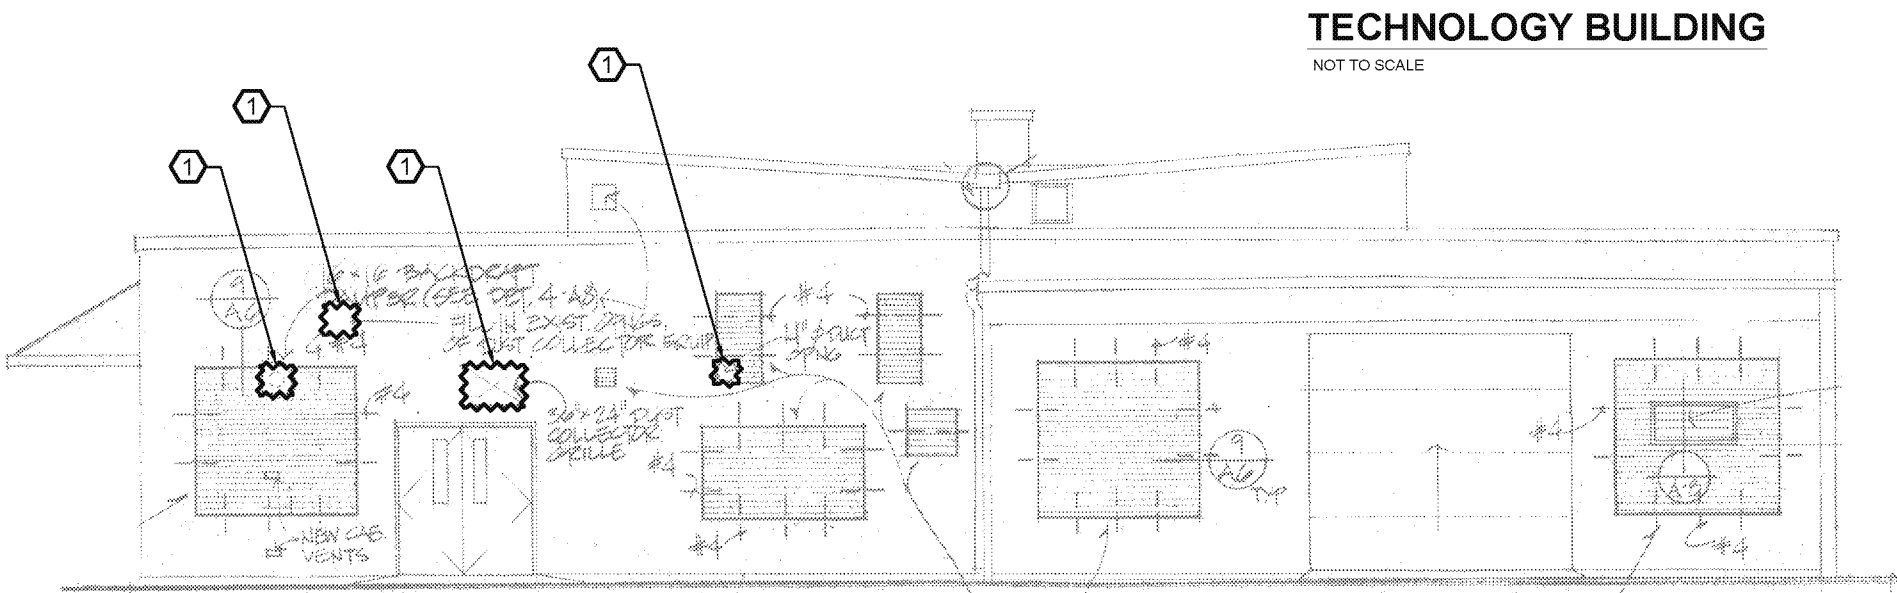
1 TECHNOLOGY BUILDING EAST
HM5 NOT TO SCALE

- 1 REMOVE APPROX. 60 LF OF PCB-CONTAINING CAULKING LOCATED ON EXTERIOR LOUVERS, VENTS AND DUCTING ON METAL TRANSITIONS ON THE WEST AND EAST EXTERIOR ELEVATIONS OF THE TECHNOLOGY BUILDING AS SHOWN.
